Report No. UT-02.14

***PHASE II: SEISMIC
REHABILITATION OF
CONCRETE BRIDGES-
VERIFICATION USING IN-
SITU TESTS AT SOUTH
TEMPLE BRIDGE ON I-15***

Construction Report

**Utah Department of Transportation
Research Division**

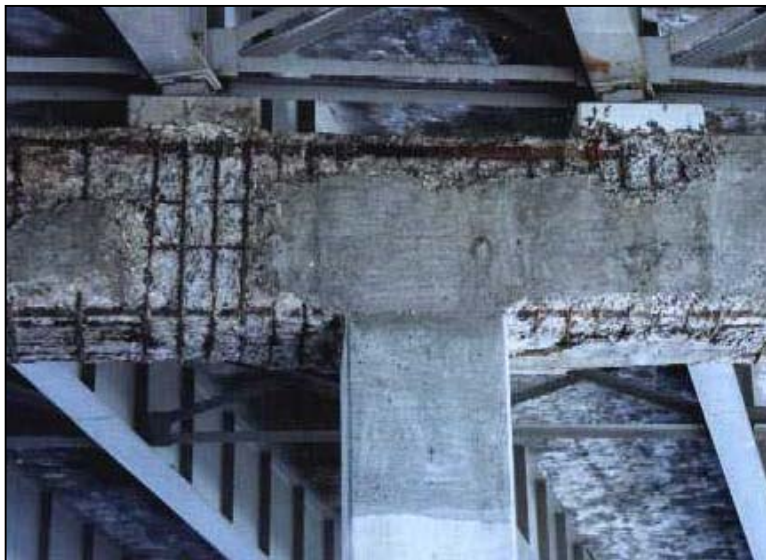
This bridge bent had large cracks and holes in the concrete beam cap and column in the areas to be retrofitted. Concrete had spalled off leaving holes approximately 1' x 4' (0.31m x 1.22m) at the corners. Rebar was exposed on the cap beam as shown in Figure 2. Shotcrete was applied to restore the cap to its original dimensions after all loose concrete was removed with water blast.

Figure 2. Cap Beam Showing Exposed Rebar and Spalled Concrete

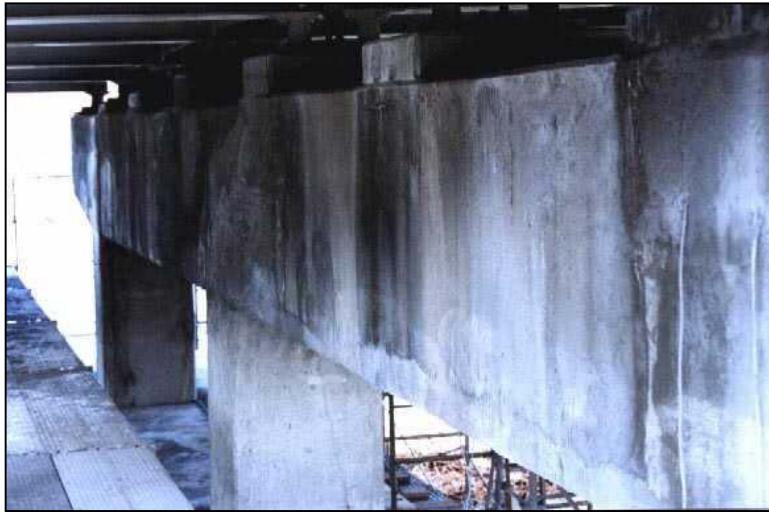
The condition of the cap beam after it was repaired with shotcrete is shown in Figure 3. This operation is necessary to bring the cap beam back to its original condition before application of the FRP composite. The columns were in a much better condition than the cap beam, and showed no evidence of corrosion. However, in order to ensure good bond of the FRP composite, they were also water washed prior to application of the FRP composite, as shown in Figure 4.

Figure 3. Cap Beam Repaired with Shotcrete

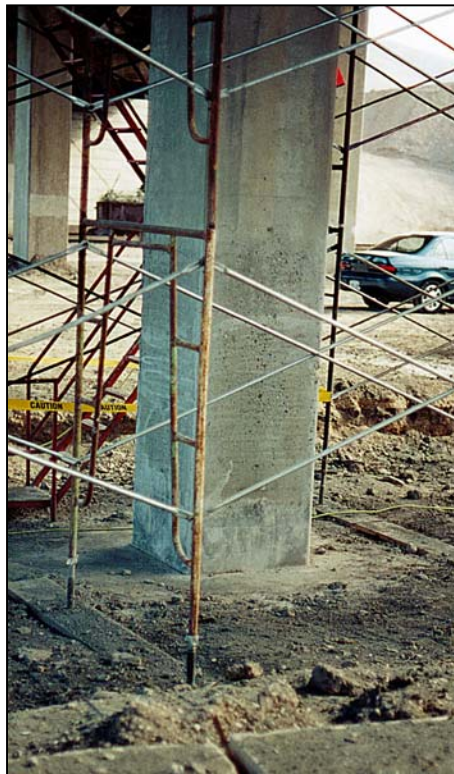
Figure 4. Water Washed and Cleaned Column

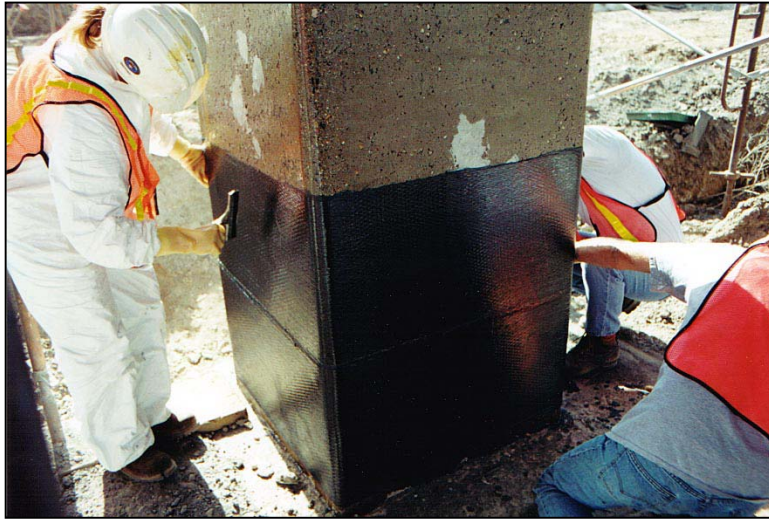
The "jelly roll" method, although saving time, may have been partially responsible for some void problems that occurred in a later phase of this project. These voids, when they were detected during application of the FRP composite, were worked out using various hand tools as shown in Figure 17.

Figure 17. Working Voids Out

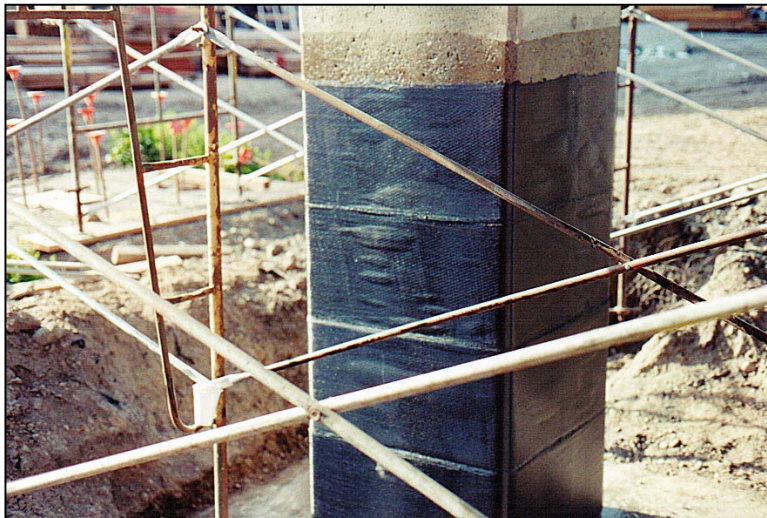
On the second day, the lower portions of the columns were inspected prior to the installation of the remaining layers of carbon. Upon inspection it was noticed that there were a number of voids found in the jackets particularly on the east and west columns, which were exposed to direct sunlight during cure. These voids were of various sizes, from small (the size of a quarter) to very large ranging from 20 in² to 30 in² (0.26 m² to 0.58 m²), as shown in Figure 19. This defect had to be addressed prior to proceeding with the remaining wraps of carbon cloth.

Figure 19. Voids in Column Jacket

There are several possible reasons for the voids forming in the jacket. It should be noted however, that voids in a confinement application such as the column, are not as detrimental as when bond is important, as in the case of the beam cap. However, the voids delay the participation of the FRP composite in the confinement effect and that is not desirable. The voids are also unsightly, and every effort should be made to avoid them.

- Jelly-roll installation process. This has been noted on other retrofit jobs.
- The resin, Sikadur® Hex 300, has a long gel and cure time. This could cause the fabric to "sag" under its own weight and cause layers to separate.

- Normally, flat surfaces, even on square columns, are treated with an adhesive prior to installation of the carbon material. In this case, however, a structural adhesive (as the first layer on the concrete) was not used.

- Out-gassing from the concrete.
- Direct exposure to the sun during cure.
- Grinding was the surface preparation vs. sandblasting which would be preferable.

The void areas were repaired using the following procedure:

- Locate the void areas.
- Drill ~ 1/4" diameter hole in the lower and upper portions of the void.
- Inject Sikadur® Hex 300 Impregnating Resin into the voids until it flows out the top hole (Figure 20).
- Plug the lower hole with Sikadur® 31 (Figure 21).
- Allow the resin to cure.

- Use of the fabric saturator is essential.
- Use of cementitious or epoxy leveling mortar on concrete before wrapping.
- Sandblast surfaces to receive FRP composite wrap.
- Use of Sikadur® Hex 306 epoxy.
- Apply fewer wraps at a time.
- Shading FRP composite from direct sunlight during cure.
- Covering FRP composite with a cementitious or acrylic coating to protect it from ultraviolet light damage for long-term performance.

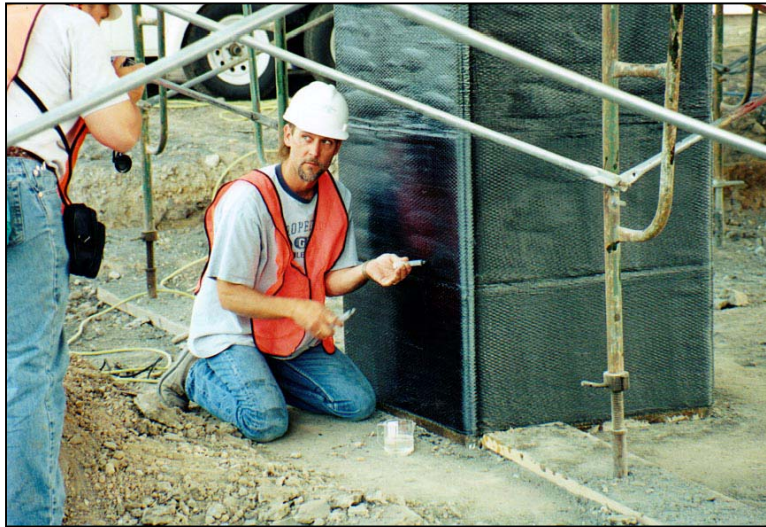
Figure 20. Injecting Resin Into Void

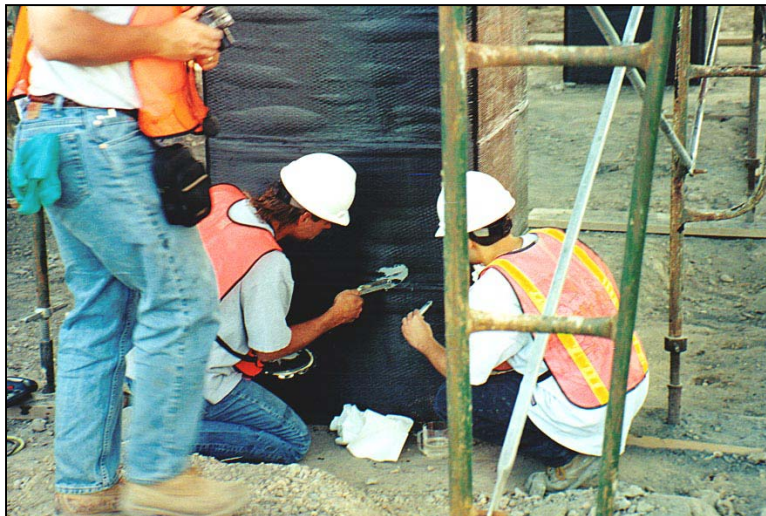
Figure 21. Profiling Material Patching Lower Hole
